**GOVERNMENT OF INDIA
MINISTRY OF CIVIL AVIATION
(COMMISSION OF RAILWAY SAFETY)**

**RAILWAY ACCIDENT INVESTIGATION
REPORT**

**Derailment of 2301 Up Howrah - New Delhi Rajdhani
Express train at km. 508/19-21 between Rafiganj and Deo
Road stations on Gaya-Mughalsarai Grand Chord Double
line Broad Gauge Electrified Section of Mughalsarai
Division of Eastern Railway on 09-09-2002**

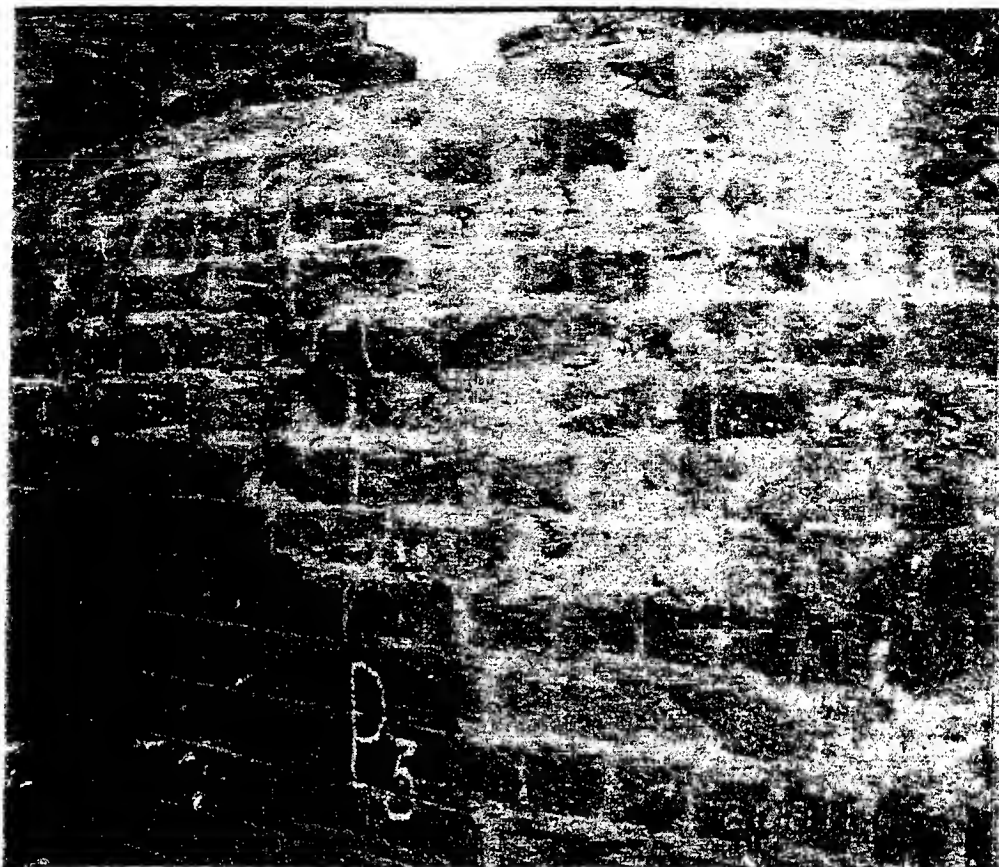
Damaged masonry pier (P-3)

Photographs clearly reveals that mortar is properly filled up and no weathering effect or voids are there.

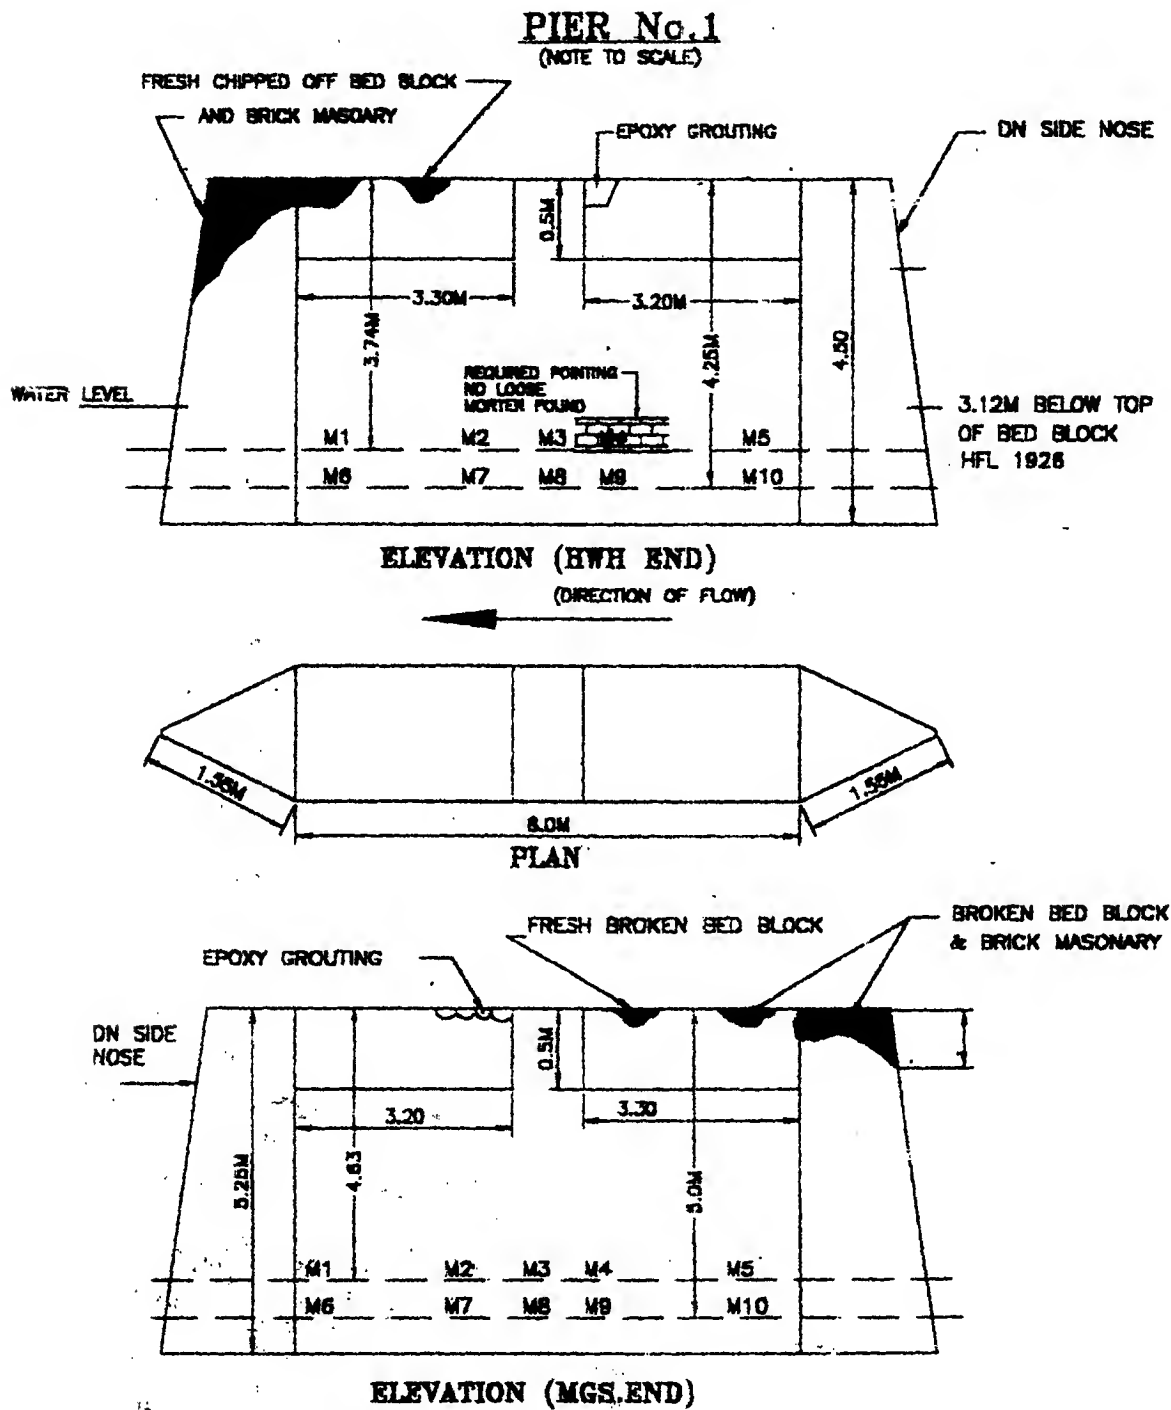
DETAILS OF SUB-STRUCTURE OF BRIDGE No.445 MGS-GAYA SECTION

1. CONDITION OF MASONRY IS SOUND, NO WEATHERING EFFECT OBSERVED.
2. NO LOOSENESS AND LEACHING OF MORTAR FOUND.
3. CONDITION OF EPOXY GROUTING IS GOOD. NEITHER ANY LOOSENESS NOR FURTHER DEVELOPMENT OF CRACK OBSERVED.
4. NO SIGN OF SCOUR OR SETTLEMENT OF FOUNDATION WAS OBSERVED.

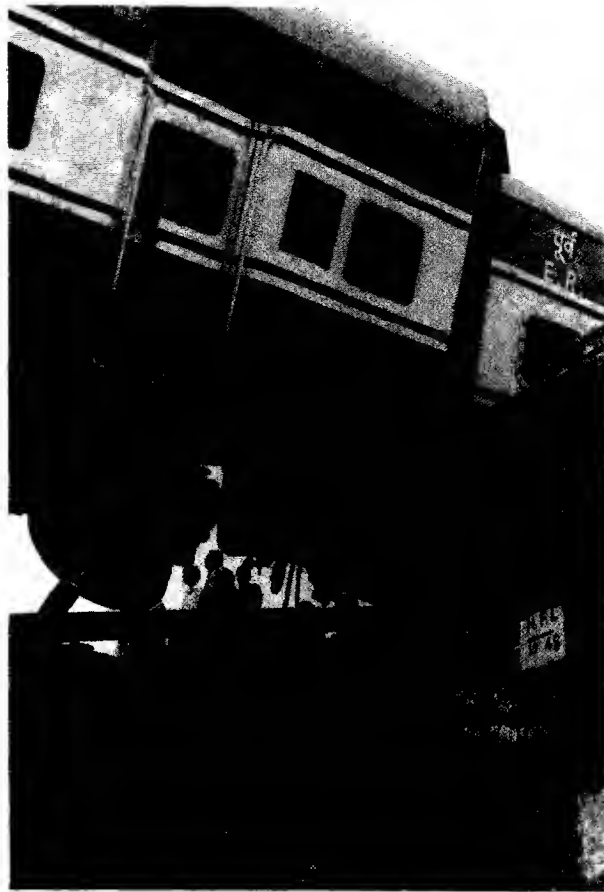
COACHES HANGING IN SPAN NO. 1 (HOWRAH END)

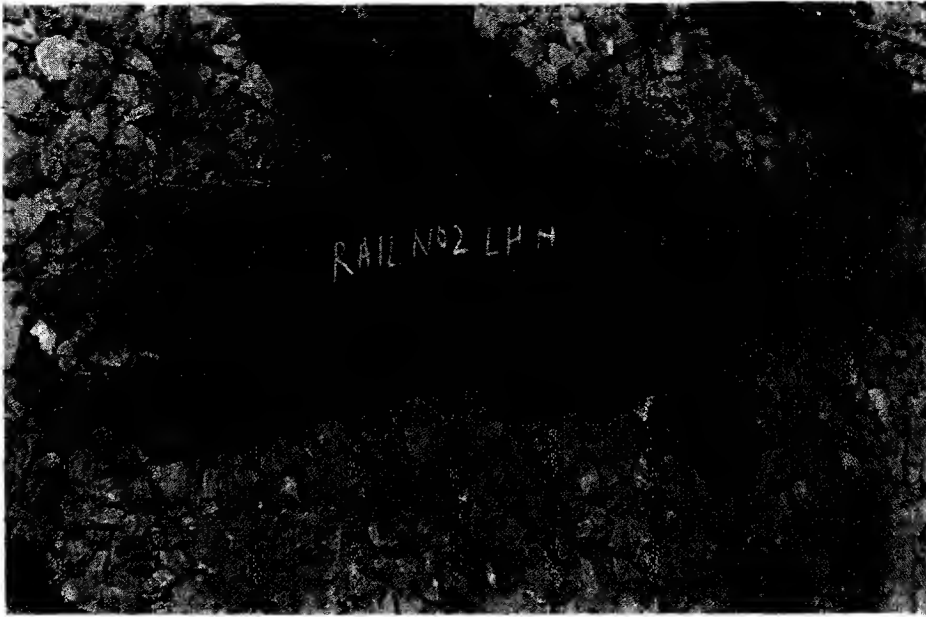
VIEW OF BATTTERED FACE OF LANDING RAIL (GAUGE FACE)
